## Introduction

## Provincial Green Drop Analysis

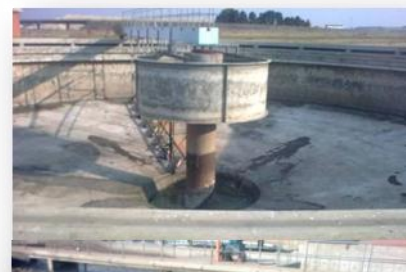
*Thabong PST under refurbishment*

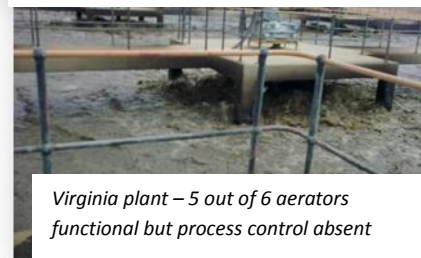
- 5 out of 6 aerators working, screening and degritting functional and sludge drying beds in good condition
- One clarifiers is functional and no disinfection takes place
- The plants is fenced in but access to the plant is possible
- No record or evidence of process monitoring or management could be inspected.

*Virginia plant – 5 out of 6 aerators functional but process control absent*

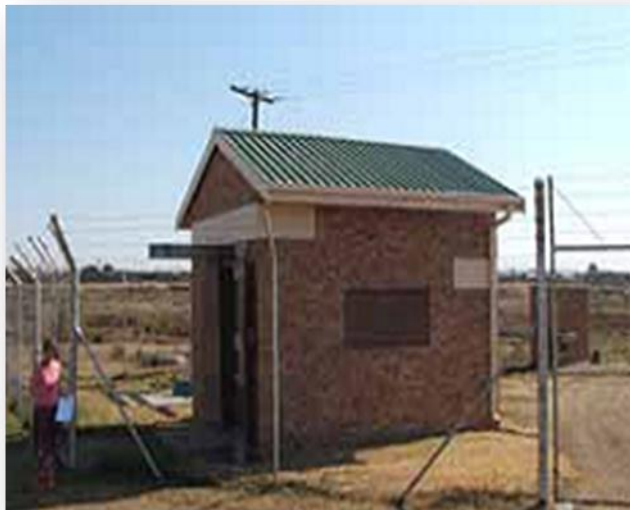
- The terrain was reasonably well maintained and fenced in with locked gates
- No procedures, manuals or monitoring equipment was in place at the plant, as these were kept at the Zastron office
- The ponds are functioning well, but the biofilter arms are stationary whilst others distribute effluent unevenly across the rock media
- Inflow measuring devices and disinfection unit are available but not functional
- Screening and grit removal are efficient but sluice gates removed which reduce controlled use of the channels.

*Fenced pumpstation at the Rouxville plant*

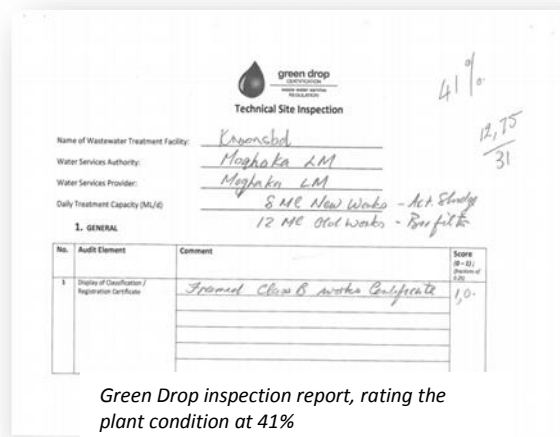
- Class B certificate is clearly displayed
- The newer part of the plant requires maintenance and all buildings are deteriorated and unkept
- The older part of the plant is in an advanced state of deterioration, but refurbishment has commenced. The construction site poses various hazards, from unhealthy conditions to safety aspects
- Major refurbishment is taking place and already improved functionality is observed. The biofilter's centre columns and effluent distribution arms, along with the mechanical upgrades, are significant improvements
- The anaerobic digesters has not been maintained and must be cleaned and recommissioned

Whilst the refurbishment is an encouraging rectification step, it is observed that as yet, no processes are in place to prevent the new infrastructure from following the same path as to what has landed the Moghaka plants in this state.

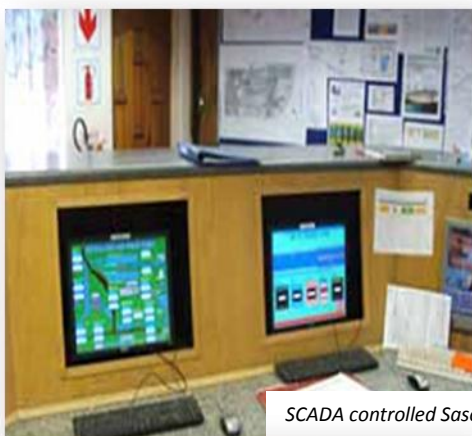
*SCADA controlled Sasolburg plant in good condition*

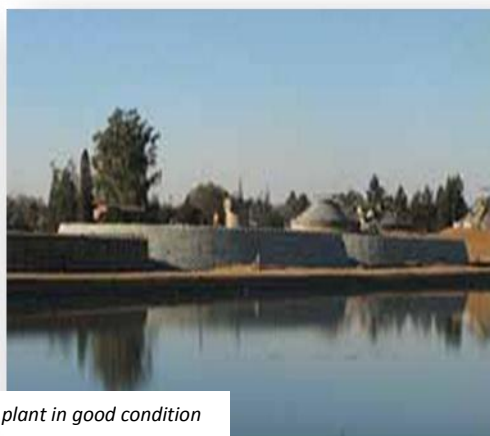
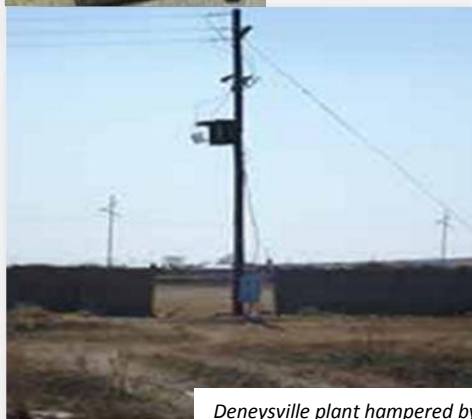
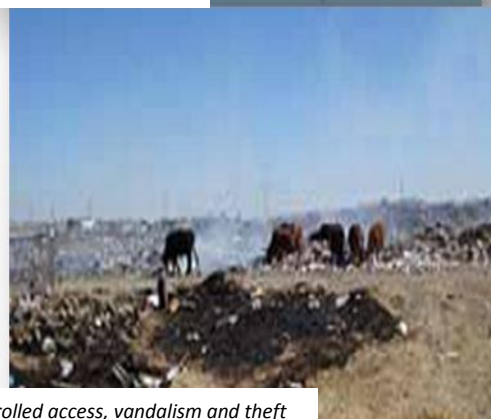
- The terrain is kept within reasonable means and most of the equipment is functional. Procedures and manuals are not in place and no flow metering is done as equipment is stolen
- A first course of action would be the securing of the premises.

*Deneysville plant hampered by uncontrolled access, vandalism and theft*

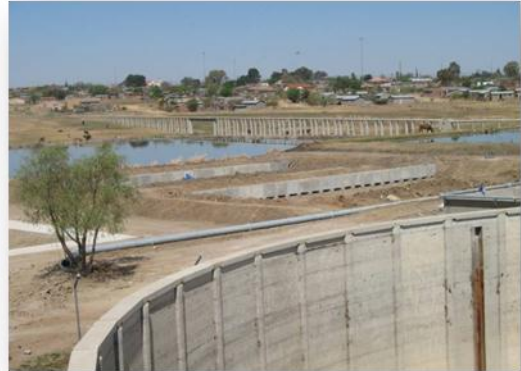
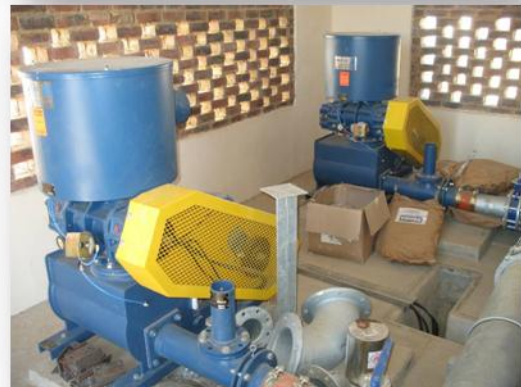
Top: 2008 construction of the new Vredefort plant;  
Below: new blower motors for diffuse aeration system.

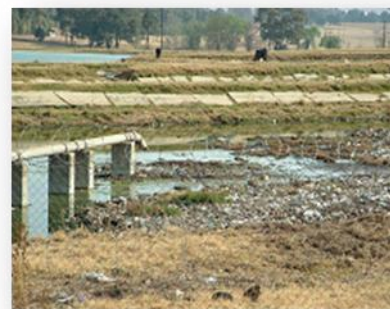
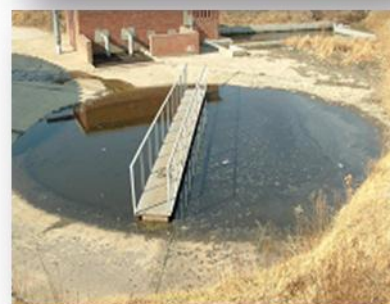
- Electrical motors are non-functional, degritting not efficient, terrain overgrown, buildings in state of disrepair and no staff to be found to attend to the problems
- Chlorine chemicals are stored in open sunlight and disinfection not adequate.
- The electrical transformer is damaged at Petrus Steyn, the biofilters are leaking and connector pipes blocked and the ponds have serious sludge accumulation and flotation
- No evidence of even remote attempts to operate and maintain these plants is found.
- Vandalism and extensive cattle grazing is evident – plant operator is under impression that cattle belongs to the technical officer and no attempts are made to removed the animals
- Screen and flow metering is in place, but not calibrated.

*Advanced state of disrepair of the Petrus Steyn plant - primary settling tanks overflowing and blocked; deteriorated ponds.*

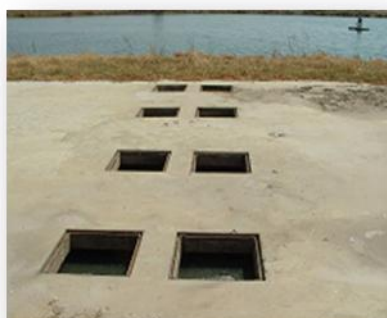
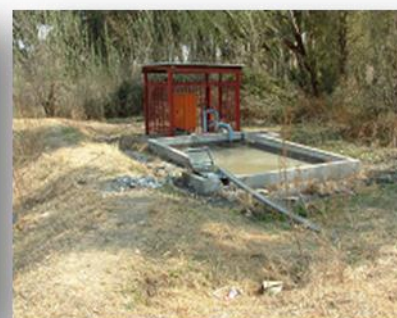
- Limited buildings on the plant and no staff is present at the site
- Vandalism at the plant forces the inlet works function to be executed at the pumpstations where screenings are removed and buried next to the pump station
- The oxidation ponds are functional, but scum and sludge visible as result of inadequate cleaning
- Encouraging, is that aerators and pumps are in working condition and disinfection takes place via 240 litre chlorine cylinders at the final discharge point
- No flow measurement, monitoring or any procedural evidence held at the plant.

*Right: Lindley town pumpstation, screenings removed manually and buried; Left: Primary settling tanks at Lindley plant, with aerated oxidation ponds in background*

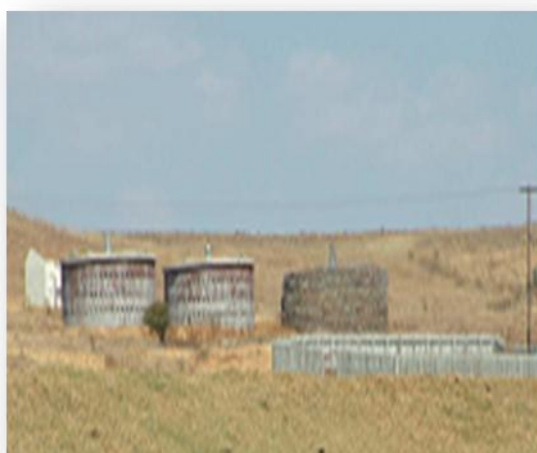
*New equipment at Warden: capital investment made despite run-down of existing infrastructure*

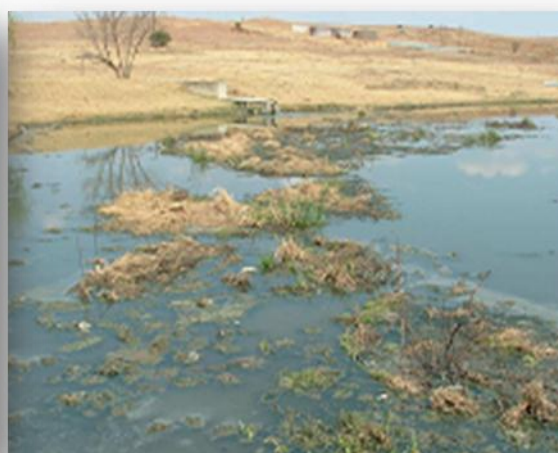
2 x bio-filters constructed. According to the WSA's technical officer, these bio-filters were out of operation for the last 5 years. No water is pumped to the bio-filters and the outlet sewer pipe to the filters was deliberately damaged to allow for the effluent to run to the river, bypassing the pump station.

*Warden biofilters and pond not functional*

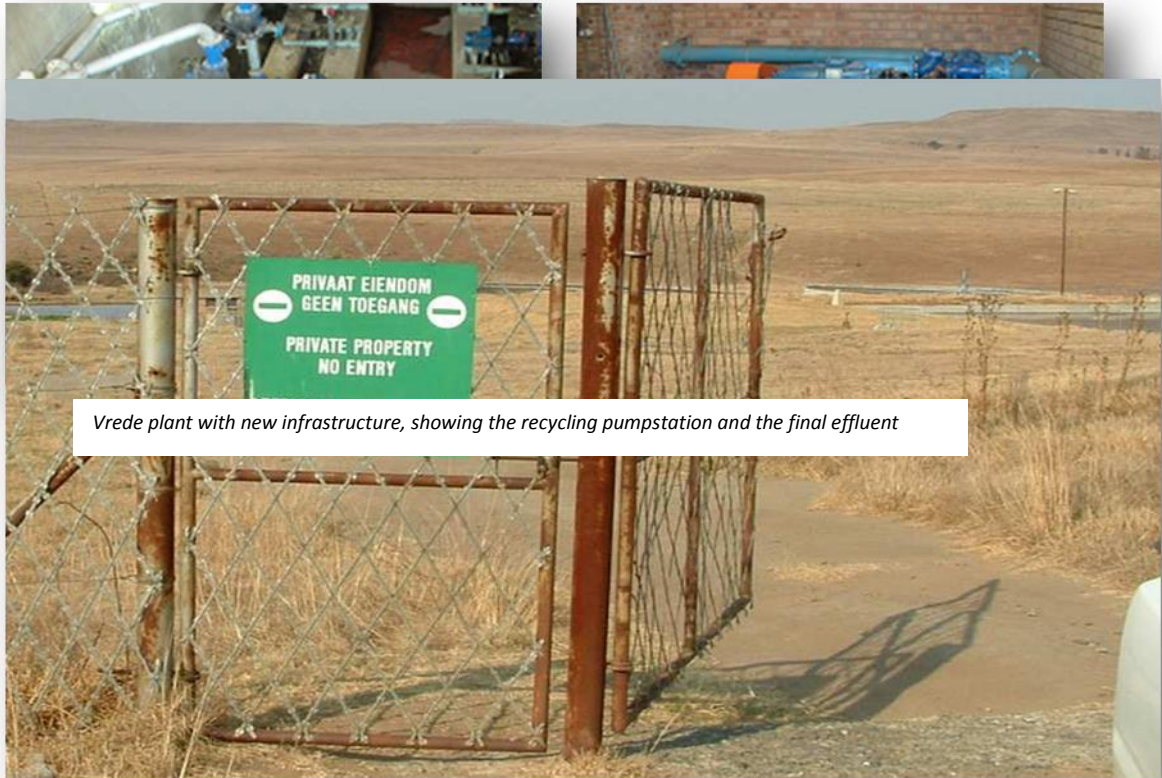
- Most equipment and structures are new and functional, but a lack of maintenance and monitoring may result in similar situation that that of the Warden plant
- Some of the treatment processes were decommissioned as result of the low flow to the plant
- Disinfection is taken place, but not monitoring equipment in place at the plant for qualitative or quantitative measurement. No operations and maintenance procedures, manuals or evidence at plant.

*Vrede plant with new infrastructure, showing the recycling pumpstation and the final effluent*

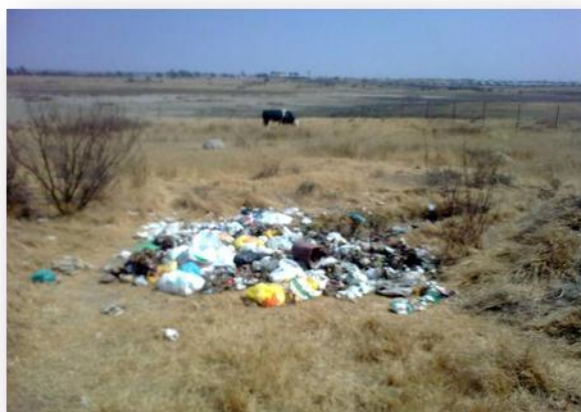
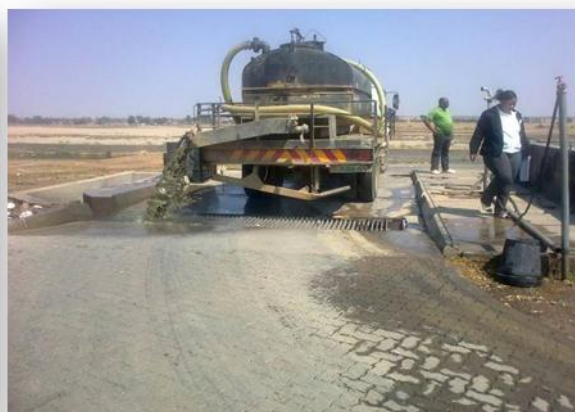
- The plant had no manuals or logbooks for flow or effluent quality on site or operators activities
- The bar screen was in place but not attended to, and the oxidation ponds showed signs of plastics and floating materials on the surface and sludge built-up in the ponds
- The discharge of effluents from road haulers was not monitored and access not controlled.

*Dealesville and Hertzogville plants experience problems with controlled vacuum tank discharge and terrain maintenance*
